PROGRAM : BACCALAUREUS INGENERIAE
MECHANICAL ENGINEERING

SUBJECT : SCIENCE OF MATERIAL 3A

CODE : MTK3A11

DATE : WINTER EXAMINATION SUPPLEMENTARY
JUNE 2018

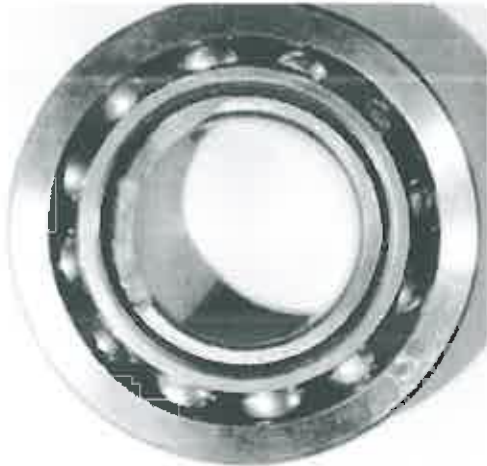
A bearing that had been in service for a year and a half was sent to undergo failure analysis (Figure 3.1). This bearing had been installed in the drive of a #P-40 centrifugal pump in a R-8 plant. It was located on a long shaft to separate the pump from the drive due to the presence of concentrated sulphuric acid. The shaft was belt driven at about 800 RPM. No special events were noticed in the pump operation.

Figure 3.1—Photograph of bearing setup

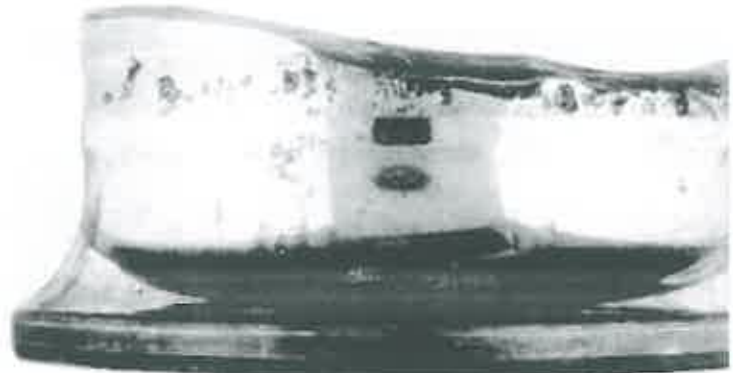
Figure 3.2—Photograph of inner ring showing spalling in groove.

Observations: The inner raceway showed severe plastic deformation around its circumference in the form of a groove, which is located above the area designed to be the ball raceway (Figure 3.2). Spalling, a flaking and cracking of the surface, was observed in the groove but was not evenly distributed around its circumference. Examination of the spalling using a scanning electron microscope (SEM) exposed flaking and the presence of surface cracks (Figure 3.3). Increased magnification of this area revealed fracture surfaces at 45° angles indicating shear loads were present (Figure 3.4).

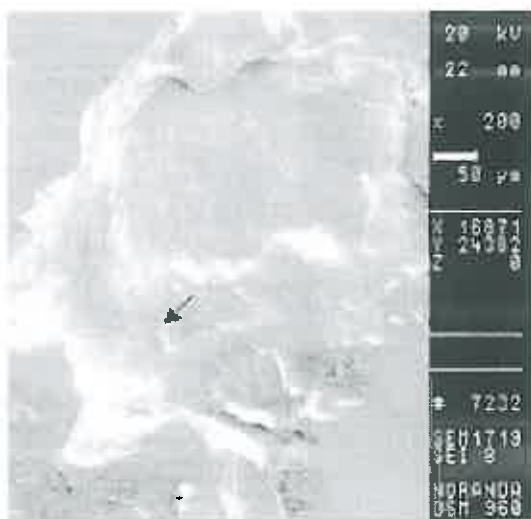
Figure 3.3—SEM photograph of spalling, flaking and cracking, in the groove. 200X

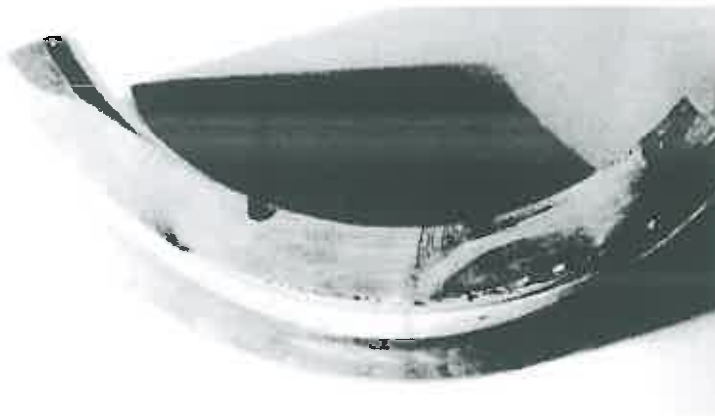
The inner raceway fracture surface is perpendicular to the groove and is located where the spalling is most severe. Beachmarks revealed several initiation sites situated in the base of the groove (Figure 3.5). Closer examination with the SEM confirms that fatigue initiated from the spalling damage (Figure 3.6). Spalling was also seen to a lesser degree on the balls surfaces. The outer raceway revealed no major defects.

Figure 3.5—Photograph of the inner ring fracture surface.

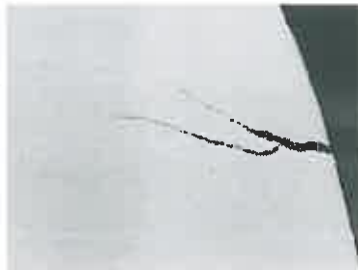
Microscopic examination of a quartered ball bearing also revealed surface cracks (Figure 3.9). A large crack extending towards the centre of the bearing was also found (Figure 3.10). The microstructure is heterogeneous, unevenly distributed; tempered martensite with undissolved carbides. The large surface crack ties along a border of the heterogeneity (Figure 3.11). Some decarburization was observed on the surface near spalling cracks.

Figure 3.10—Microphotographs of crack in a ball. 15X

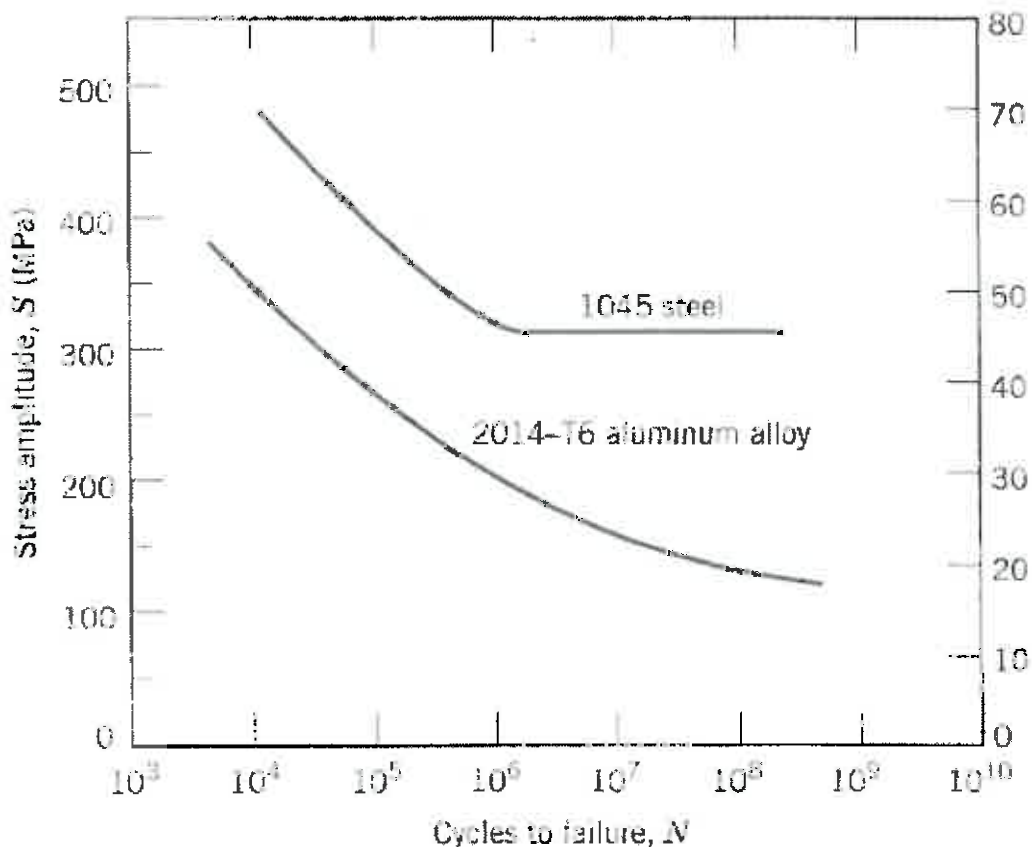
4.3 5.2mm diameter cylindrical rod fabricated from 2014-T6 aluminium alloy is subjected to a repeated tension-compression load cycling along its axis. Determine the maximum and minimum loads (in Newton) that will be applied to yield a fatigue life of 1.0×10^8 cycles. Assume that the data in Figure 4.1 were taken from a mean stress of 35MPa.

Figure 4.1—Stress amplitude S versus the number of cycles N
