PROGRAM : **MECHANICAL ENGINEERING**
SUBJECT : **SCIENCE OF MATERIAL 3A**
CODE : **MTK3A11**
DATE : (WINTER SUPPLEMENTARY EXAMINATION)
DURATION : 3 HOURS (1-PAPER)
TOTAL MARKS : 100

EXAMINER : Mr. T Mathonsi
MODERATOR : Prof. RF Laubscher
NUMBER OF PAGES : 6 PAGES

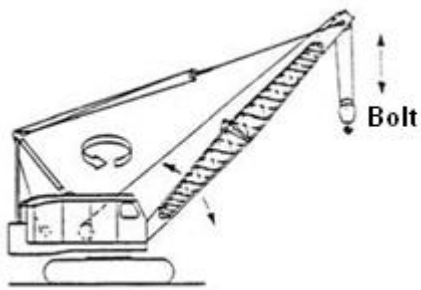
One of two bolts supporting a load of 7400 kg failed while in service causing eight hours of downtime on an essential machine for production. The bolts were in operation on a crane used to transfer anodes into the machine. Figure 2.1 shows a drawing of the set-up and the location of fracture just above the nut. The crane cycled 600 times a day 7 days a week.

Figure 2.1. Drawing of the bolt and crane set-up.	Figure 2.2. Photograph of a broken bolt	Figure 2.3. Photograph of the fracture surface.

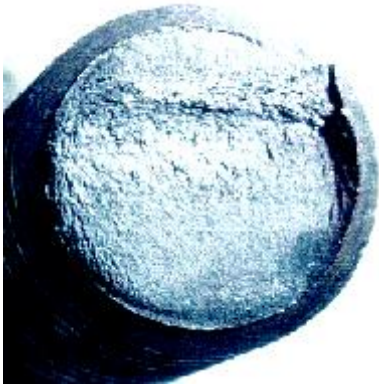
Examination of the fracture surface revealed characteristics such as a beachmarks associated with fatigue (Figure 2.3). The zone of the final fracture was located between two areas of fatigue propagation suggesting the presence of bending forces. The surface area of the final fracture was approximately 12% of the total fracture surface suggesting that the bolt was not overloaded. Cracks were also found between threads near the fracture surface indicating that the bolt was highly susceptible to fatigue initiation.

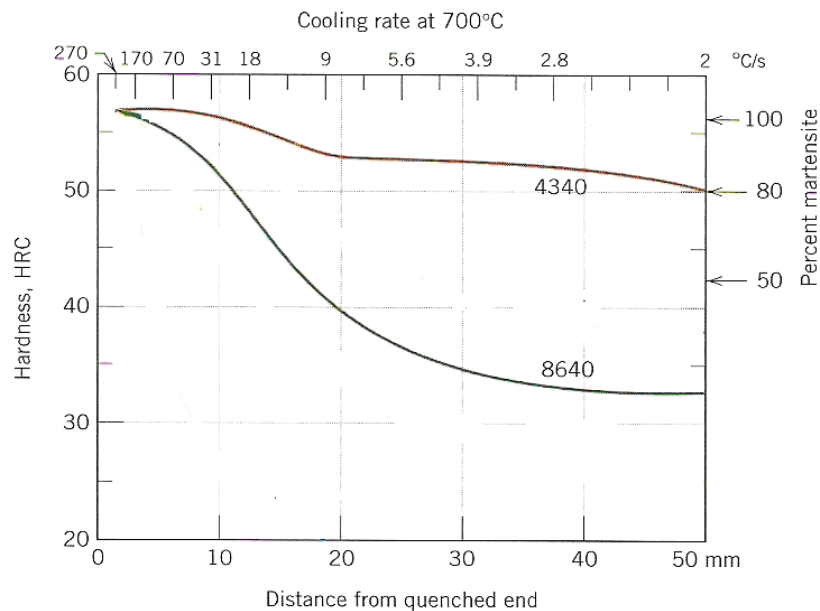
Figure 6. Hardenability curves of 4340 and 8640 alloy

Given the hardenability curves of 4340 and 8640 alloy steel generated from Jominy end-quench tests (see Figure 6), discuss:
