**PROGRAM** : MECHANICAL ENGINEERING  
**SUBJECT** : SCIENCE OF MATERIAL 3A  
**CODE** : MTK3A11  
**DATE** : 8 JUNE 2019 (WINTER EXAMINATION)  
**DURATION** : 3 HOURS (1-PAPER)  
**TOTAL MARKS** : 100

Read the following case study of a failure analysis that was performed on a stainless steel reducer and answer the questions that follow:

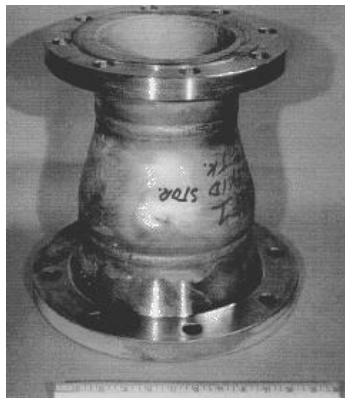
*A 200 x 150 mm, 316L stainless steel reducer was sent for failure analysis, shown in Figure 2.1. It had been in service for 13 months when a leak was noticed. The reducer was installed on an acid storage tank. The anodically protected carbon steel tank, contained concentrated 93% sulphuric acid. The flow rate through the reducer was 1500L/min.*

**Figure 2.1—316L reducer.**

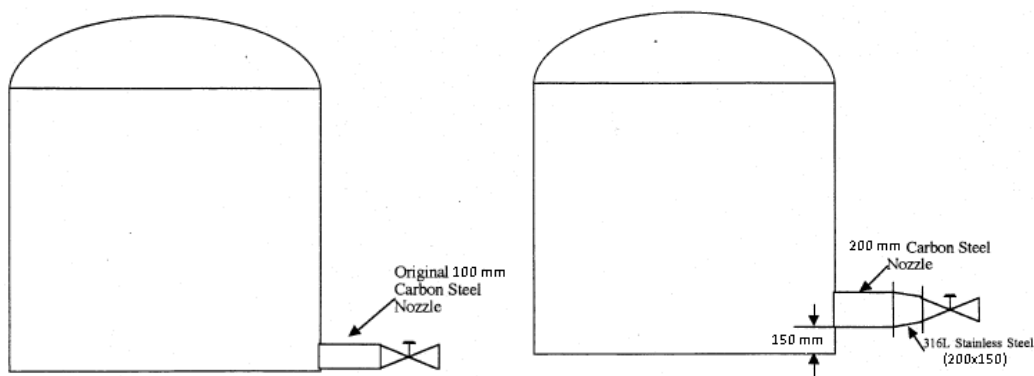
*The tank was originally designed with a 100 mm diameter carbon steel nozzle, at floor level, that connected directly to a valve shown in Figure 2.2(a). This lasted seven to eight years without incident. The design was changed to accommodate renovations so that a 200 mm carbon steel nozzle was installed 150 mm above the tank floor. This nozzle leads into the failed reducer, which then connects to a valve composed of alloy steel, as illustrated in Figure 2.2 (b). The valve then leads to a 150 mm pipe made of 316L stainless steel in which no problems were found.*

**Figure 2.2 (a) Old tank installation. (b) Tank installation at the time of reducer failure.**

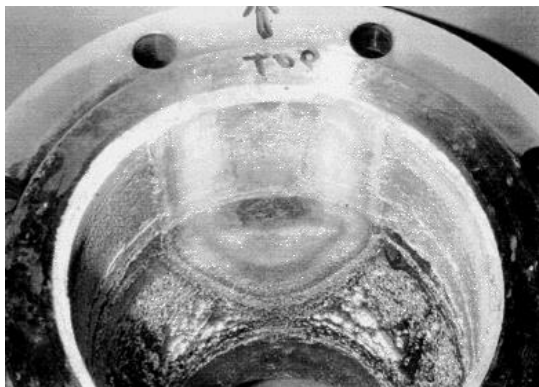
**Observations:** Visual examination of the reducer revealed an area at the top where little to no damage was observed (Figure 2.3). This area, which was probably an air pocket, extended from the top of the 200 mm diameter flange into the reducing pipe where it stopped just before the 150 mm diameter flange. Damage in this area consisted of minor pitting shown in Figure 2.4. Damage, resembling a honeycomb structure in places, was most severe just below the air pocket in the reducing pipe near the 150 mm diameter end (Figure 2.5 (a) and (b)). The arrow in Figure 2.5 (a) indicates where the leak occurred. The leak was discovered on the outside of the reducer (Figure 2.6). The damage becomes less severe in the pipe section towards the bottom. Only pitting was found in both the 200 and 150 mm flanges.

**Figure 2.3—Photograph of the top insider of the reducer showing the area at the top where little damage occurred.**

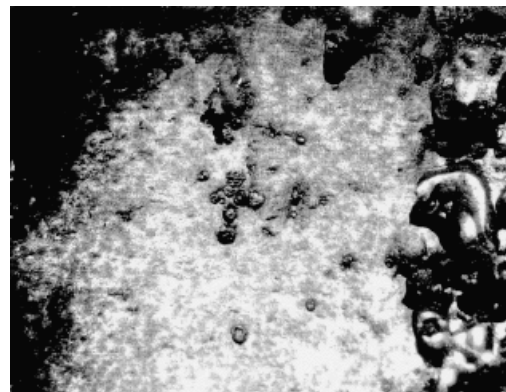
**Figure 2.4—Microphotograph of pitting in air pocket. 15X**

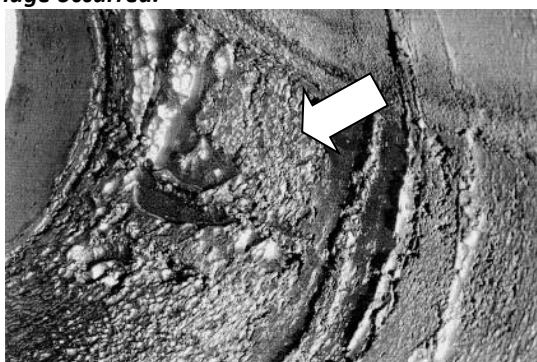
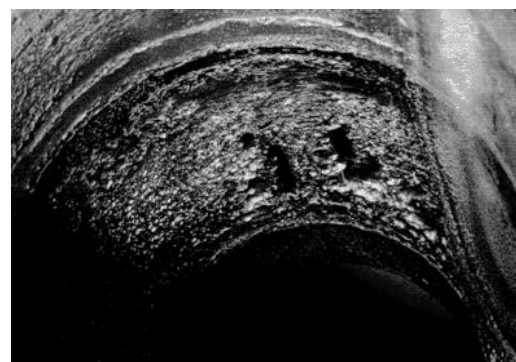
**Figure 2.5—Photographs showing areas to the (a) right and (b) left of the top relatively undamaged surface. The arrow in (a) indicated where the leak occurred.**

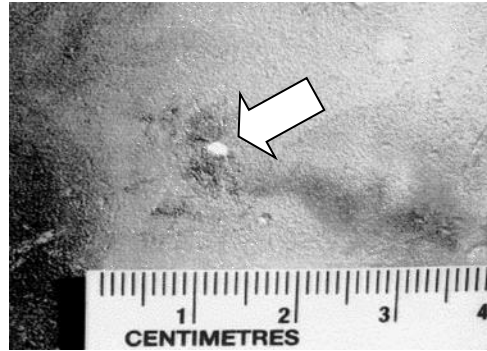
**Figure 2.6—Photograph taken on the outside of the reducer showing the hole where the reducer leaked.**

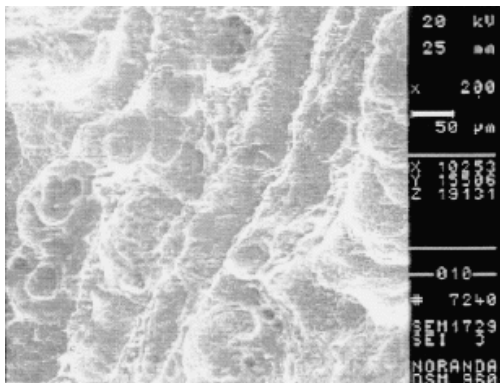
Closer examination of the inside surface of the reducer with a SEM revealed dimples (Figure 2.7). These features are typical of ductile deformation. The orientation of the features also follows the direction of liquid flow, which indicates erosion of the surface. Pitting and uniform corrosion was also found in this region (Figure 2.8).

**Figure 2.7—SEM photograph of the inside surface of the reducer in the damaged area. 200X**

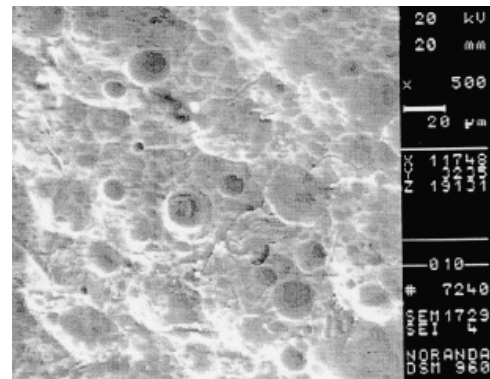
**Figure 2.8—SEM photograph of the inside surface of the reducer in the damaged area. 500X**
