**PROGRAM** : MECHANICAL ENGINEERING  
**SUBJECT** : SCIENCE OF MATERIAL 3A  
**CODE** : MTK3A11  
**DATE** : (WINTER SUPPLEMENTARY EXAMINATION )  
**DURATION** : 3 HOURS (1-PAPER)  
**TOTAL MARKS** : 100

## QUESTION 1

## QUESTION 2

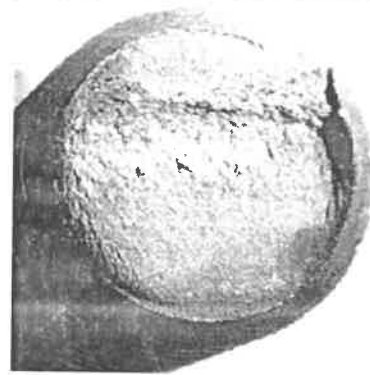
Figure 2.3. Photograph of the fracture surface.

Examination of the fracture surface revealed characteristics such as beachmarks associated with fatigue (Figure 2.3). The zone of the final fracture was located between two areas of fatigue propagation suggesting the presence of bending forces. The surface area of the final fracture was approximately 12% of the total fracture surface suggesting that the bolt was not overloaded. Cracks were also found between threads near the fracture surface indicating that the bolt was highly susceptible to fatigue initiation.
